CITY OF BURLINGTON
COMBINED SEWER OVERFLOW UPDATE

DRAFT
December 2012

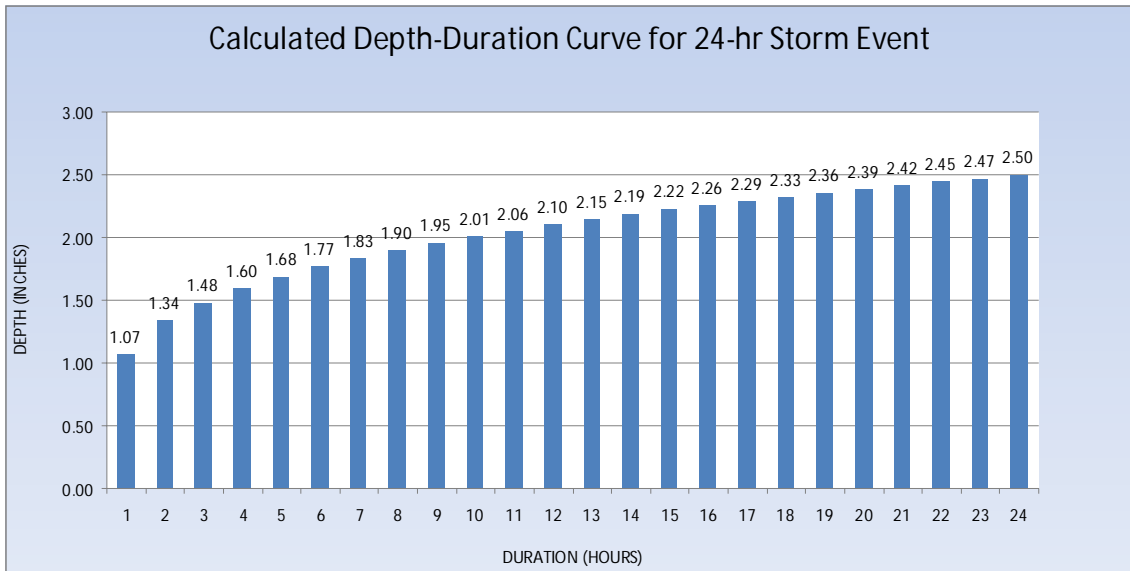
It has been generally recognized that rainfall intensity (depth over time) plays as much a role in the volume of surface runoff and corresponding overflows than total depth. One or more inches of rainfall in one hour is significantly different than the same depth over longer periods of time. While Vermont's 1990 CSO policy only mentions total 24 hour rainfall depth, later documents released by the State mentioned a peak hour intensity of 1.07 inches. This was determined to be derived from the SCS (Soil Conservation Service) Type II synthetic rainfall distribution developed by Hershfield (1961) and Frederick et al. (1977). This synthetic distribution is widely used when there is a lack of actual rainfall data. In 2008 we had proposed a different hourly intensity and depth-duration curve using real precipitation data from the National Weather Service office at the Burlington International Airport, however this data was deemed to be unacceptable in various conversations with State representatives. So, using the SCS Type II distribution, the 2.5"/24 hr Depth-Duration Curve looks like this:

This curve is a simple attempt in evaluating storm events since every storm is different in duration and intensities. This curve should be used as follows: if an actual storm lasts, for example, three (3) hours and had a recorded rainfall depth greater than the curve's 3 hr/1.48" depth, that storm was greater than a 2.5"/24 hr storm event. In the future we should look at curves with time intervals shorter than one hour to address flash storms that dump water in minutes.

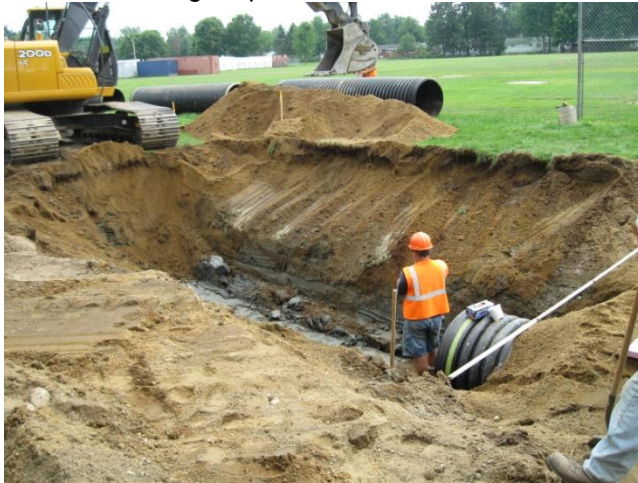
CP Smith Storage Pipe

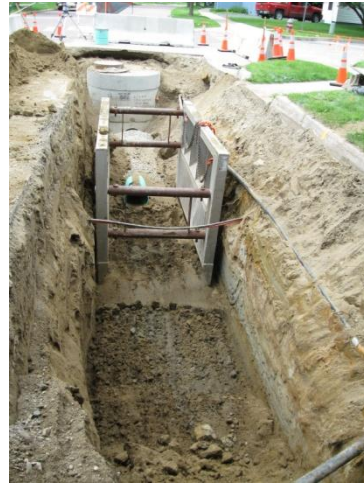
CP Smith Connection to James Ave

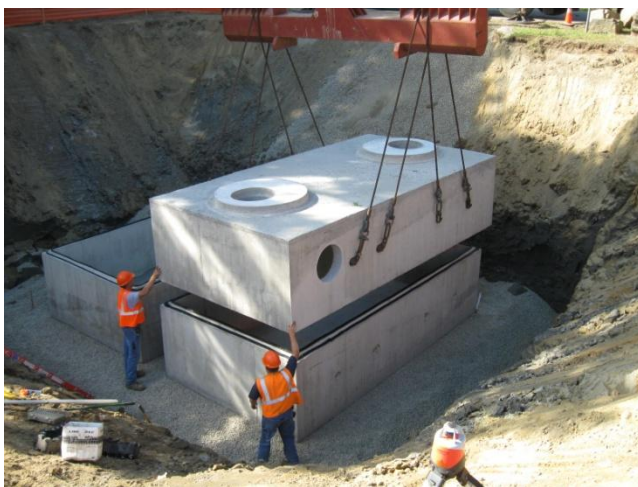
LC Hunt Storage Tanks

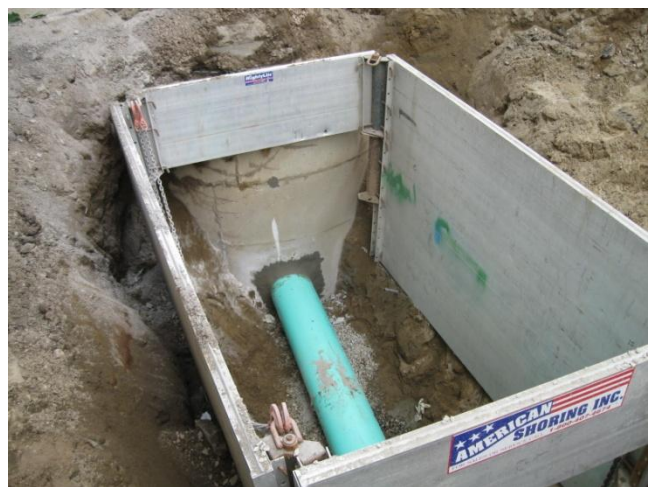
LC Hunt Connection to Storm System

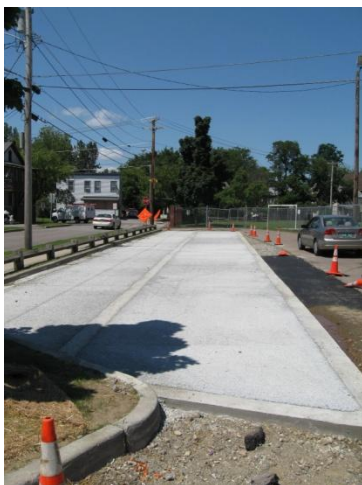
HO Wheeler Pervious Concrete Paving

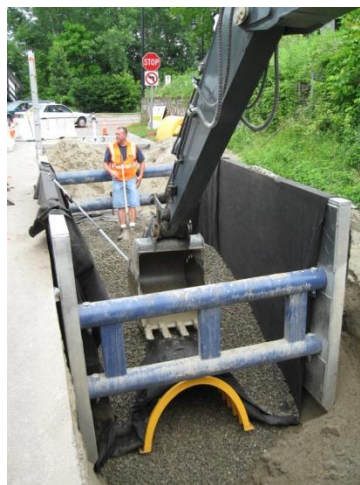
Typical Infiltration Chamber Installation

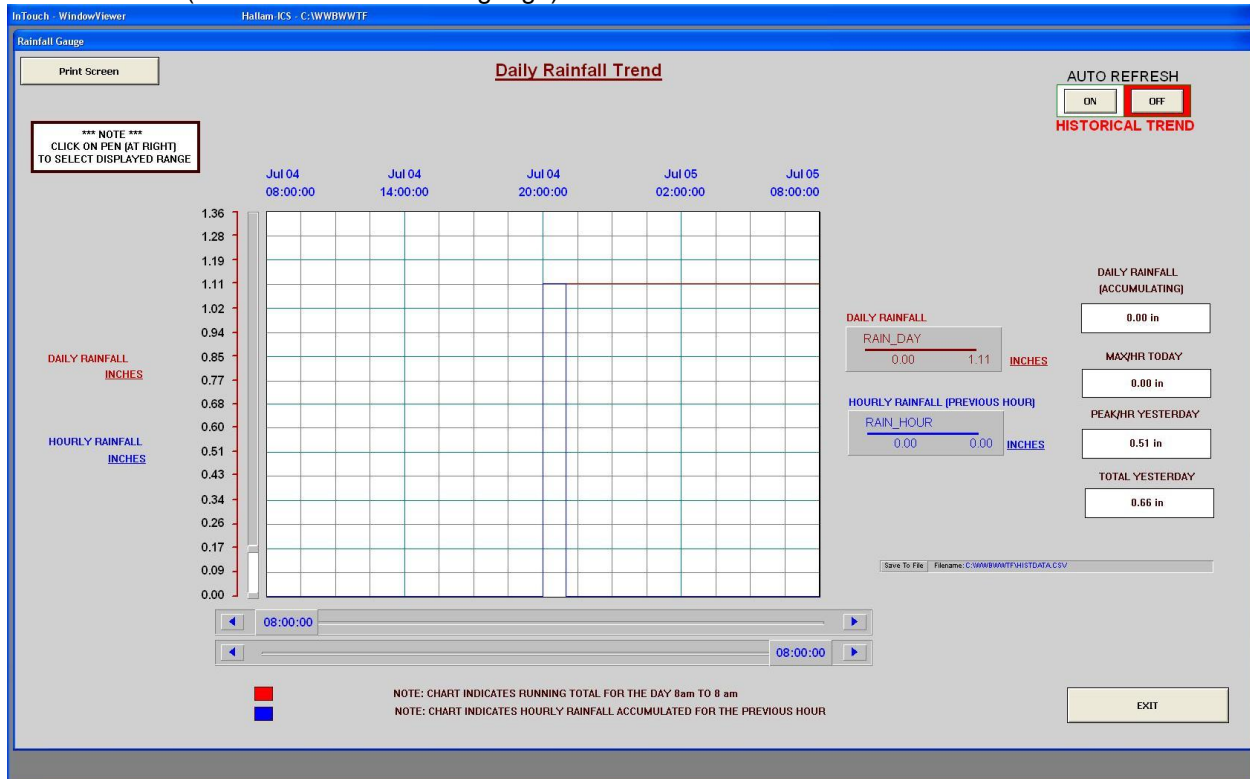
7/4/12 Rainfall (source: Main Plant Raingauge)

DATE	RAINFALL (total/hrs, peak intensity)	(a) CSO MINS MANHATTAN @ PARK	(b) CSO MINS MANHATTAN @ N. CHAMP.	(c) CSO MINS GAZO AVE	(d) CSO MINS COLCHESTER AVE	CSO COM- PLIANT
7/4/12	1.11"/1	41	21	0	54	Y, note 1
7/17/12	0.68"/12, 0.51"	29	0	0	23	N - a,d
7/23/12	0.83"/7, 0.35"	0	0	0	12	N - d
8/5/12	0.30"/2, 0.29"	0	0	0	7	N - d
8/10/12	0.61"/7, 0.45"	16	0	0	5	N - a,d
8/11/12	0.96"/2, 0.91"	34	0	27, note 2	28	N - a,d
9/4-9/5	3.33"/7, 1.15"	51	0	0	140	Y, note 1
9/8/12	0.32"/3, 0.29"	0	0	0	10	N - d

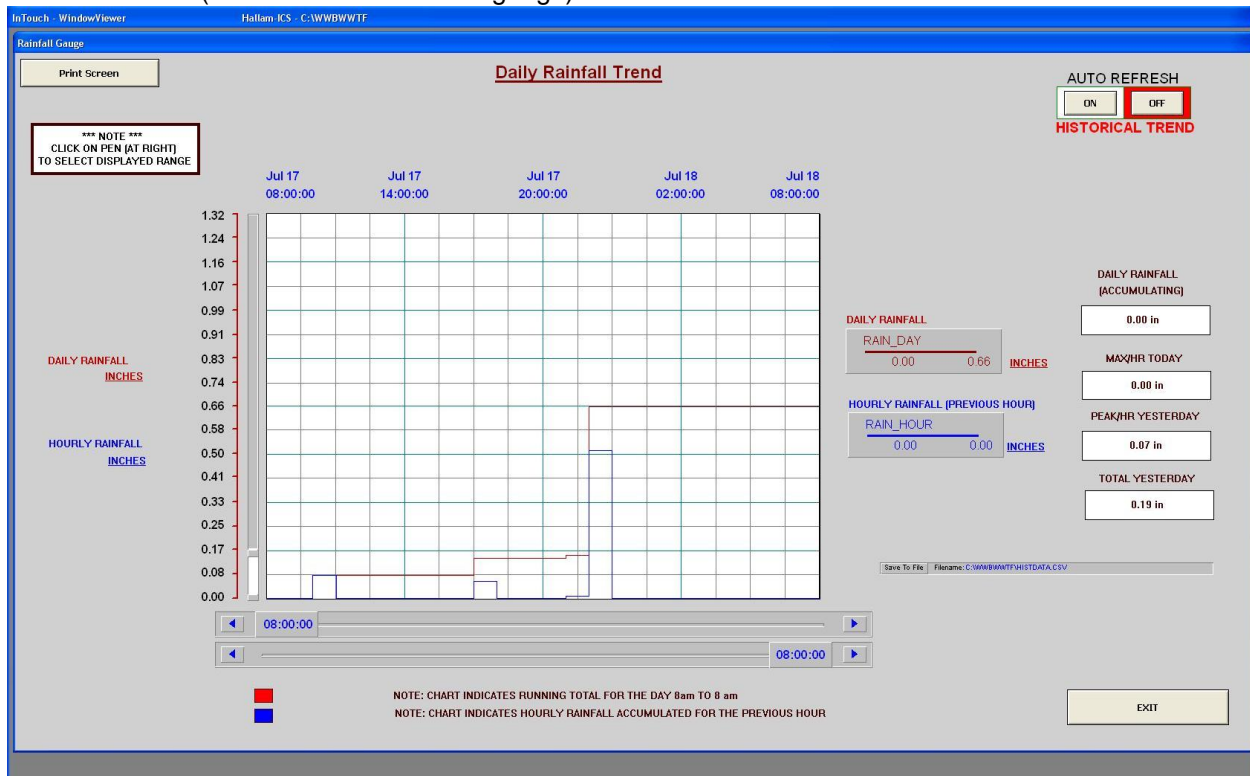
7/17/12 Rainfall (source: Main Plant Raingauge)

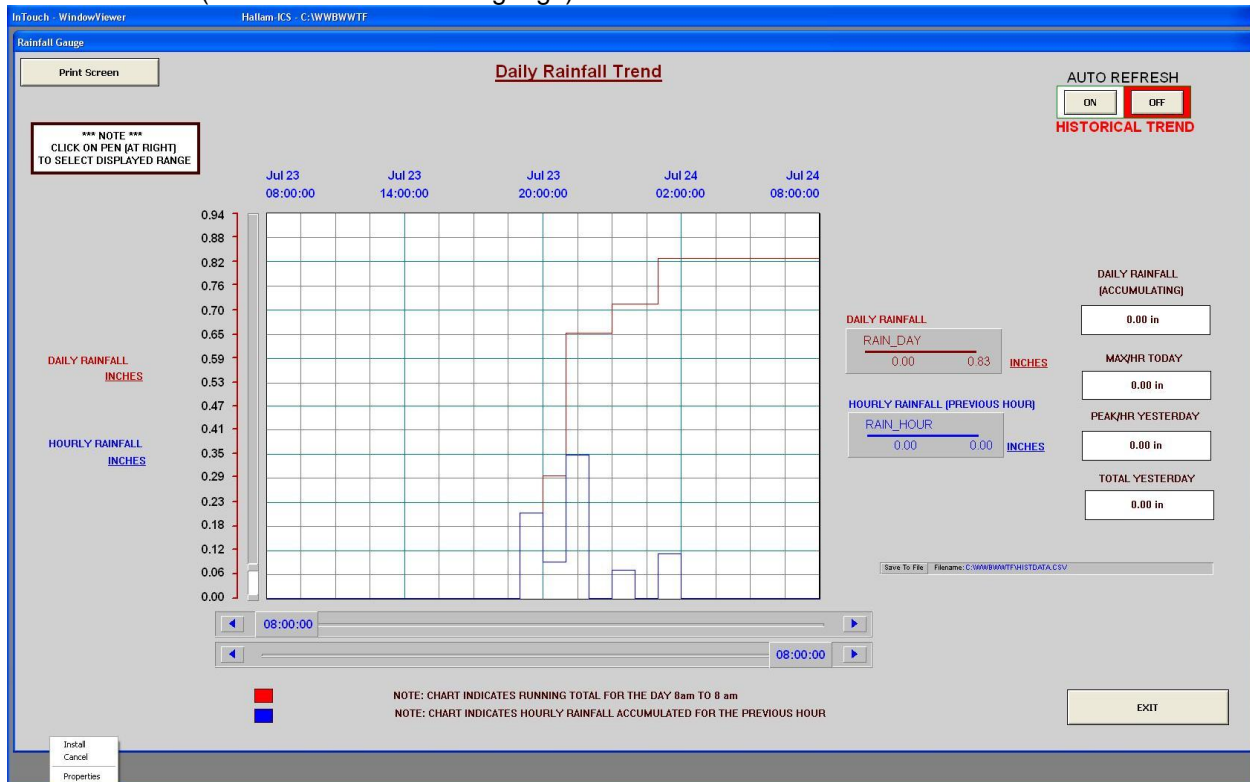
7/23/12 Rainfall (source: Main Plant Raingauge)

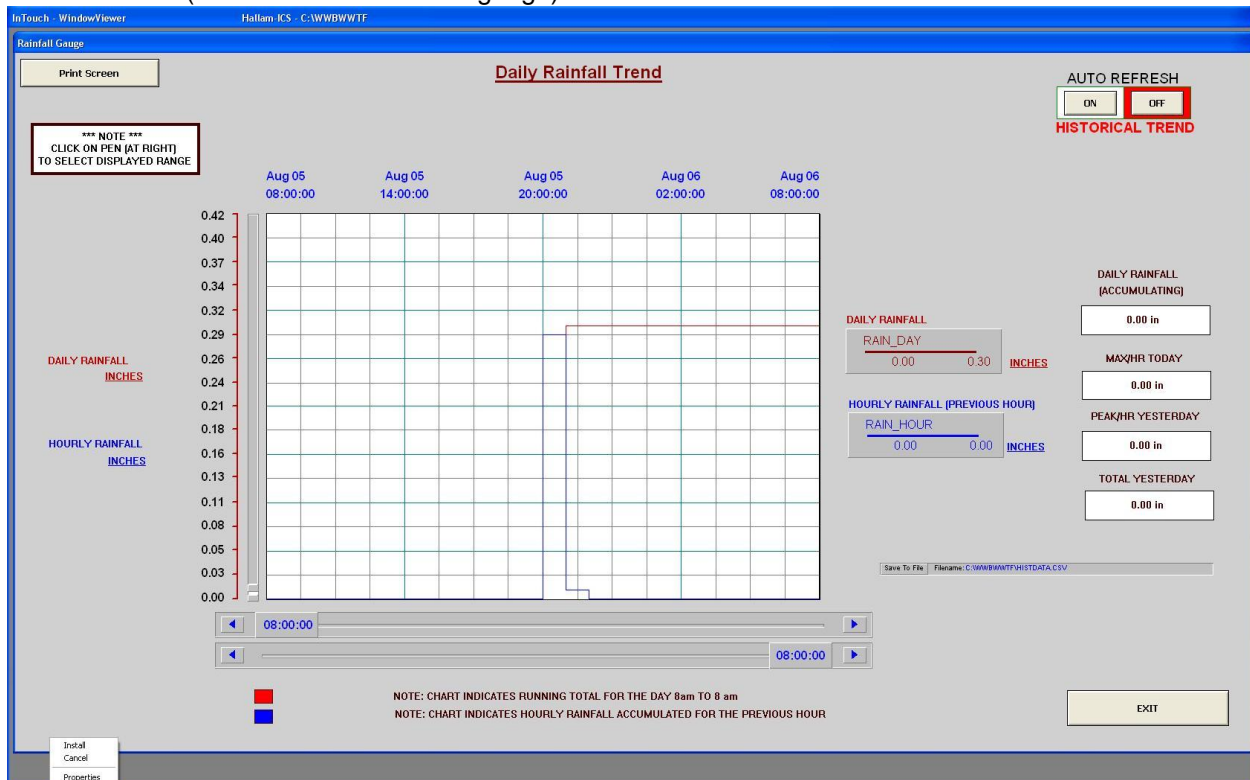
8/5/12 Rainfall (source: Main Plant Raingauge)

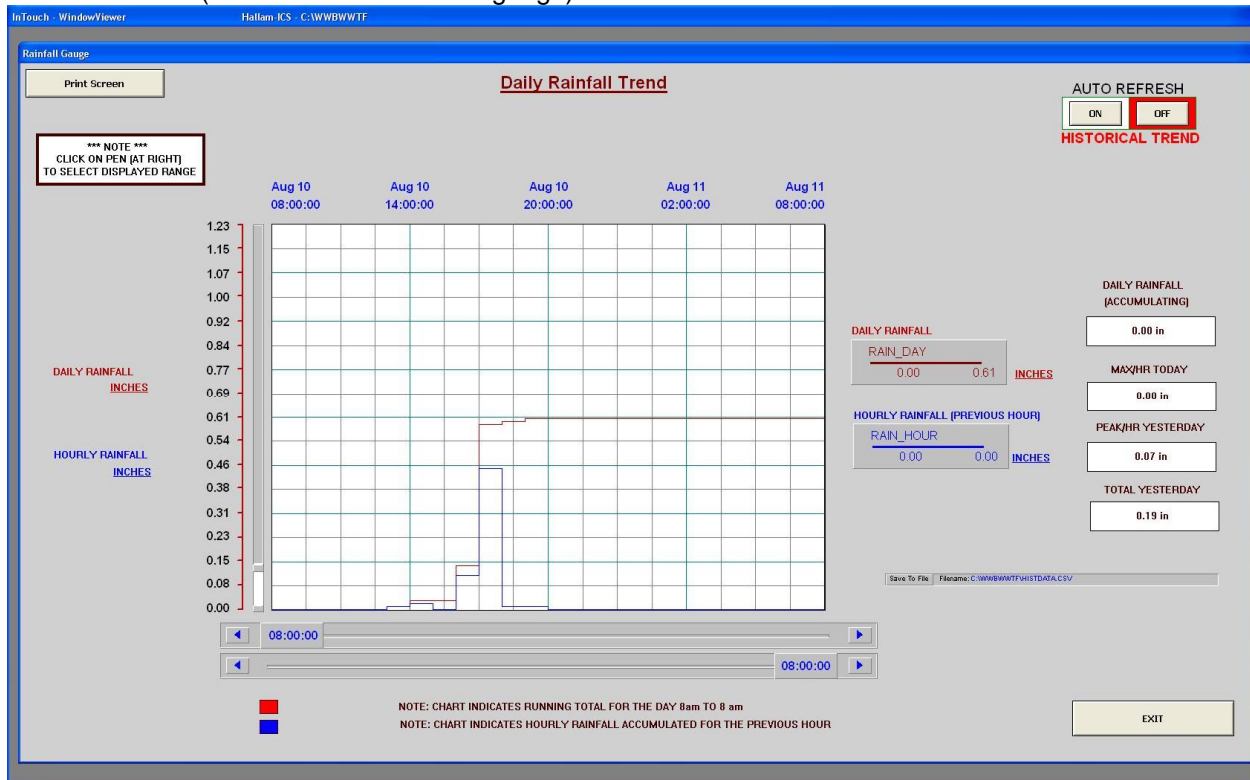
8/10/12 Rainfall (source: Main Plant Raingauge)

1. July 4 and September 4/5 storms are deemed compliant since these storm's depths or intensities exceeded the 2.5"/24 hr SCS Type II event.
2. Gazo overflowed on August 11 due to reduced soil infiltrative capacity from two prior days of rainfall (0.87" on 8/10 and 0.14" on 8/9). It did not overflow during the two storms exceeding State requirements. The preceding wet weather also applies for Manhattan system.
3. There were no other storms this year that were close to the 2.5"/24 hr event and no overflows occurred.

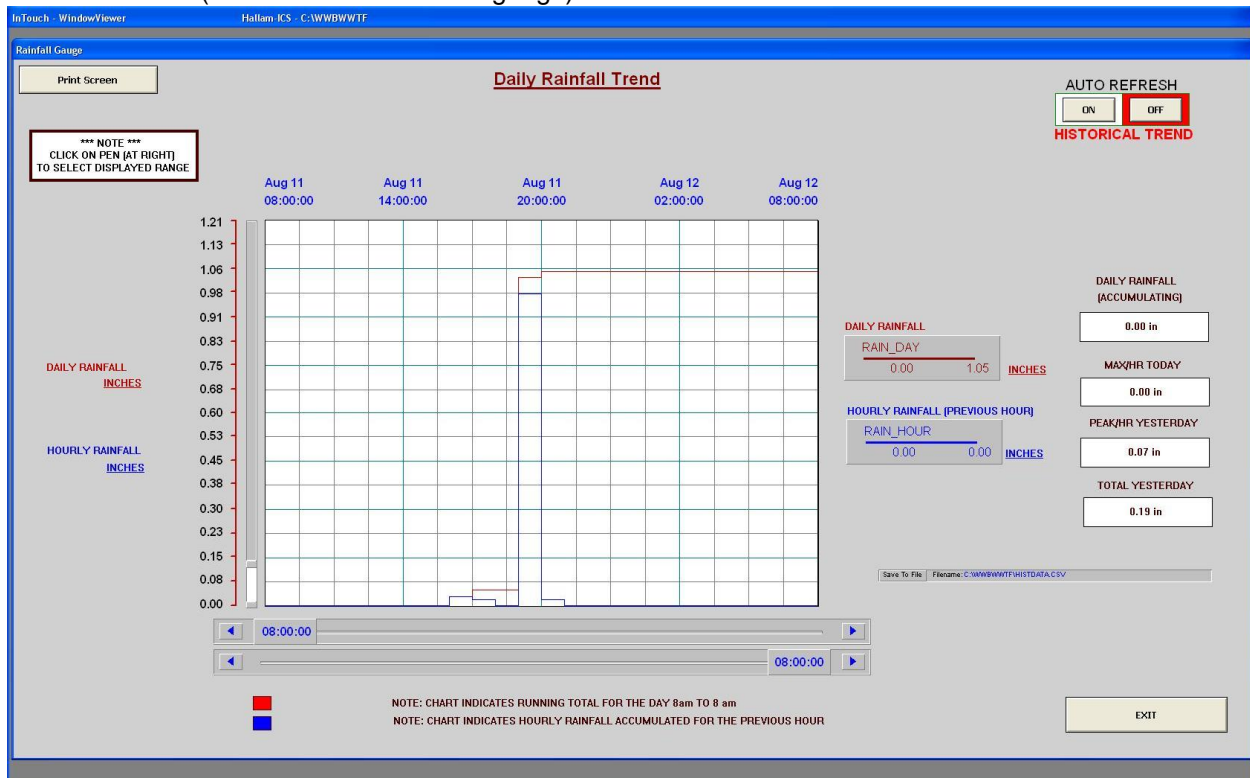
8/11/12 Rainfall (source: Main Plant Raingauge)

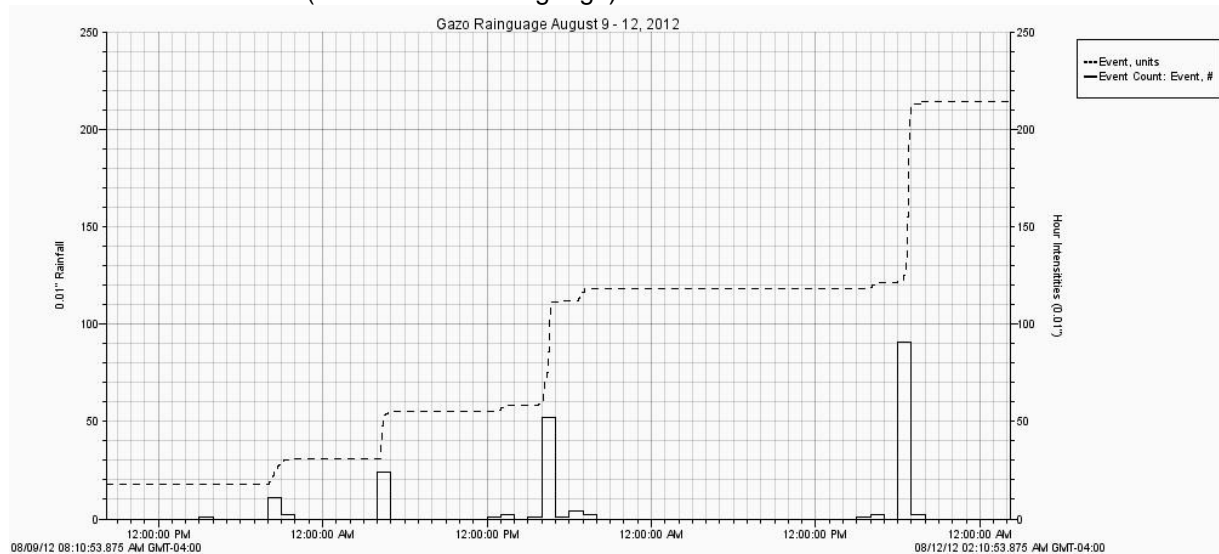
8/9/12 – 8/12/12 Rainfall (source: Gazo Raingauge)

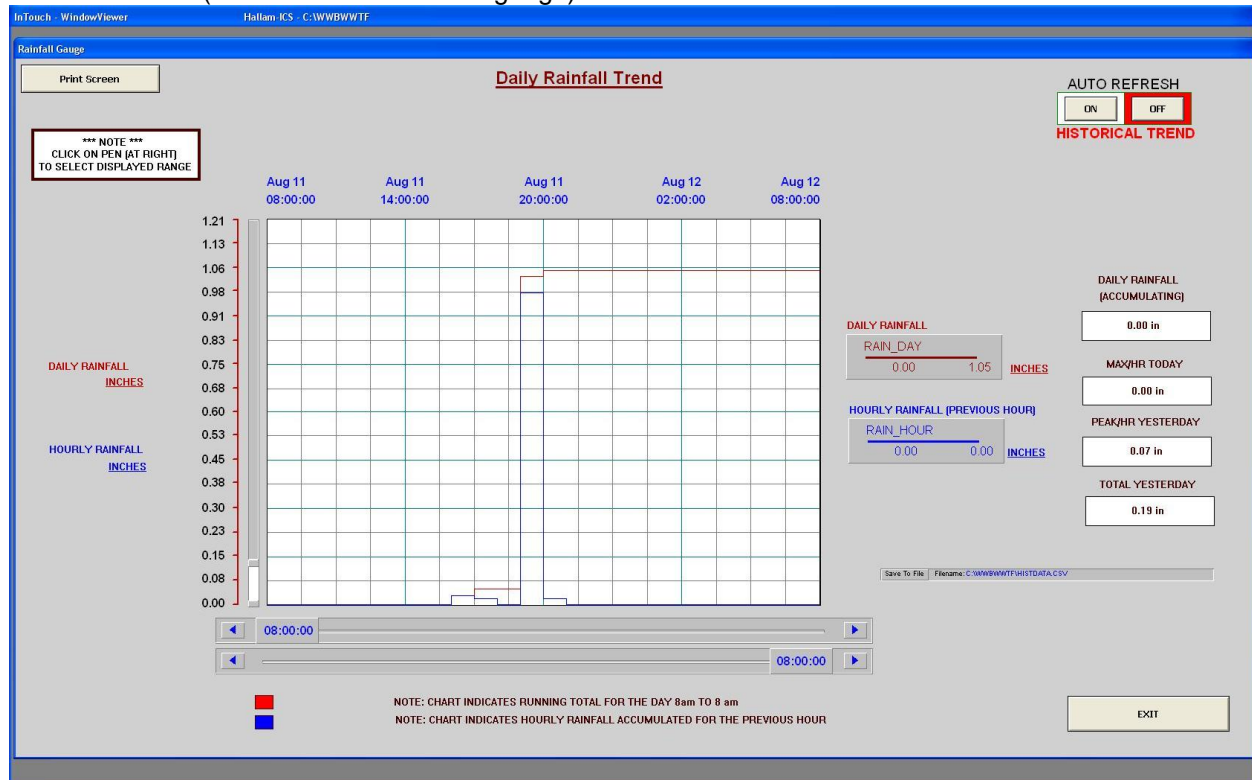
8/11/12 Rainfall (source: Main Plant Raingauge)

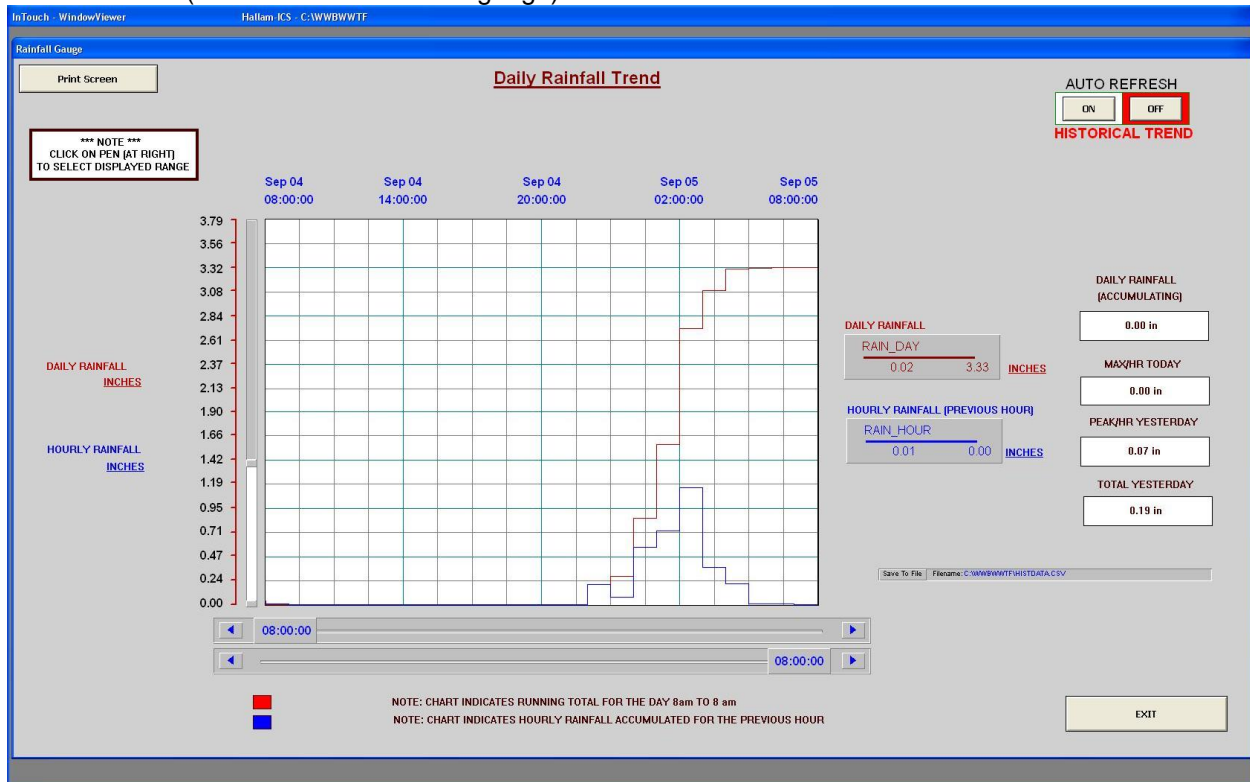
9/4/12 Rainfall (source: Main Plant Raingauge)

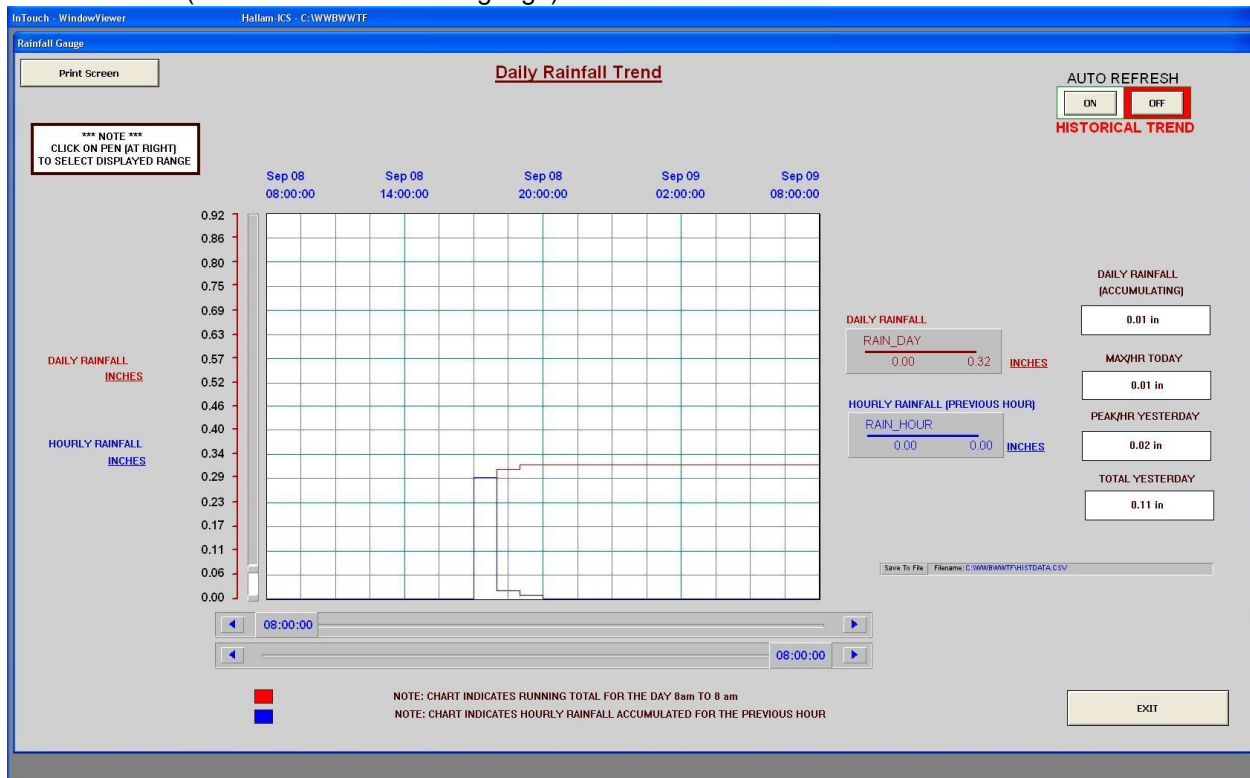
9/8/12 Rainfall (source: Main Plant Raingauge)
